IMPORTANT SAFETY NOTICE

NHTSA CAMPAIGN NUMBER 07C006

August 2007

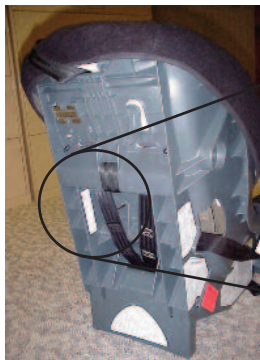
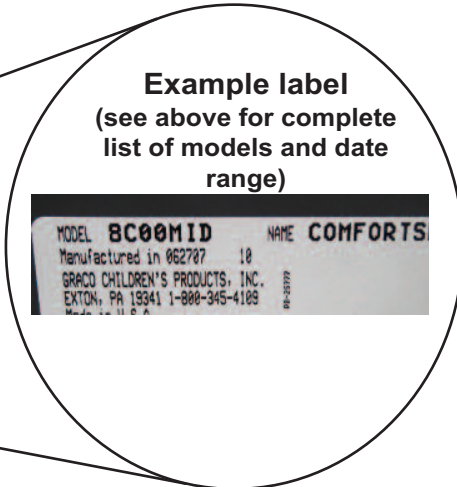
A label with the model number, model name and date of manufacture is located on the back of the child restraint. If after checking the label on your child restraint, you determine that it is affected by this notice, follow the steps on the next page to check the routing of the Lower Anchorage belt.

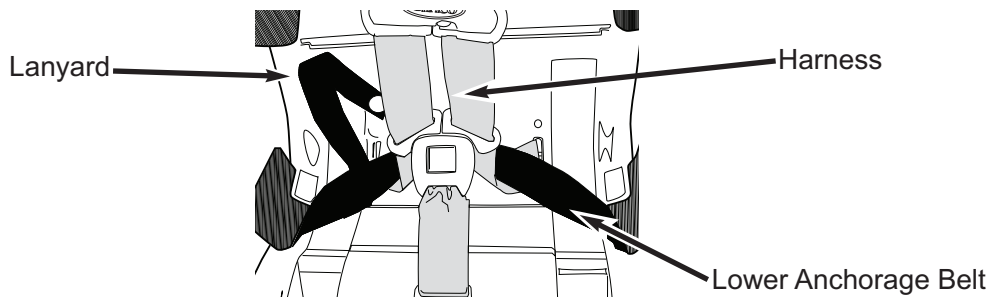
On some of these child restraints, the Lower Anchorage belt was misrouted under the shoulder portion of the harness during assembly, instead of under the crotch belt/buckle section of the harness. If the child restraint is installed in the rear-facing mode and the Lower Anchorage belt is attached to the vehicle's LATCH anchor, the seat back angle of the child restraint can exceed 70 degrees in a frontal crash. This increased rotation may increase the risk of injury to the child.

INCORRECT ROUTING FOR REAR-FACING MODE

Remove the Lower Anchorage belt from behind the harness straps and place it under the crotch strap portion of the harness as shown above, keeping the belt flat and tight against the child restraint so that it does not interfere with the harness system. The lanyard attaching the Lower Anchorage belt may be on either the right or left sides of the harness. Depending on which way your lanyard is mounted, assemble as shown above.

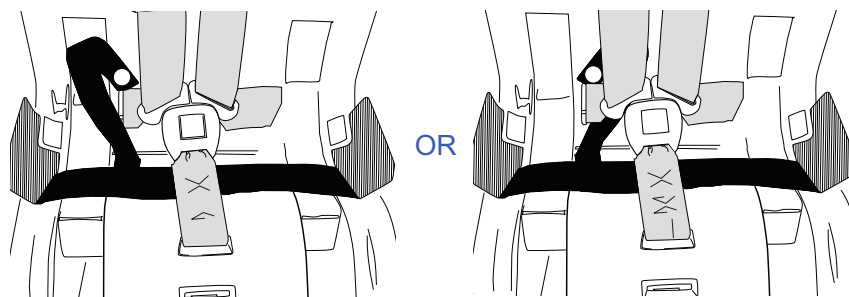
CORRECT ROUTING FOR REAR-FACING MODE with LANYARD on the LEFT side

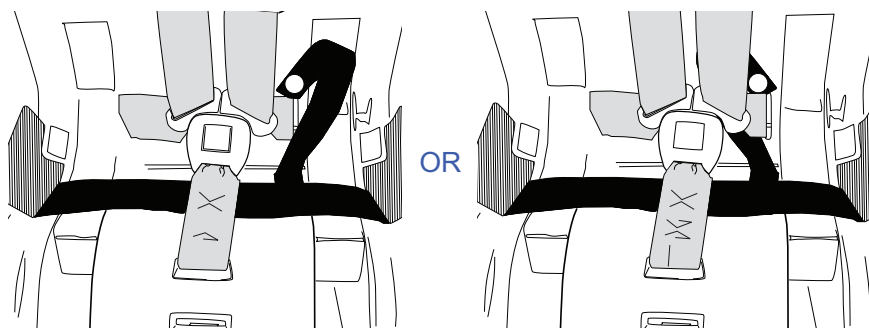
CORRECT ROUTING FOR REAR-FACING MODE with LANYARD on the RIGHT side
