1. Check the Lower Anchorage Belt Placement.

2. Reroute the Lower Anchorage Belt if Necessary:

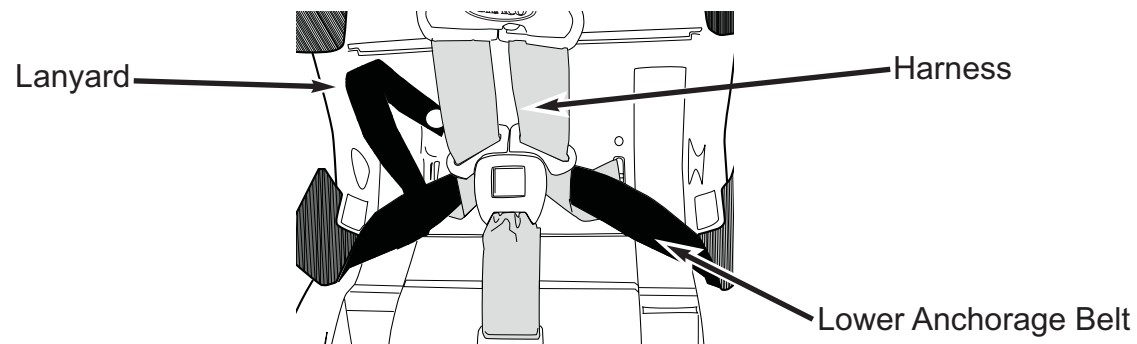
INCORRECT ROUTING FOR REAR-FACING MODE

Remove the Lower Anchorage belt from behind the harness straps and place it under the crotch strap portion of the harness as shown above, keeping the belt flat and tight against the car seat so that it does not interfere with the harness system. The lanyard attaching the Lower Anchorage belt may be on either the right or left sides of the harness. Depending on which way your lanyard is mounted, assemble as shown above.

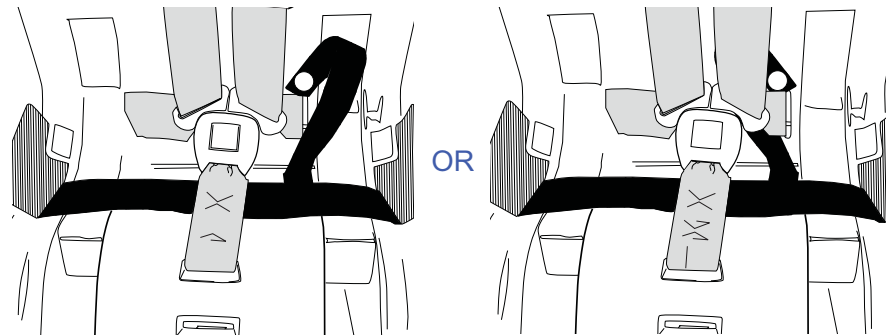
CORRECT ROUTING FOR REAR-FACING MODE with LANYARD on the RIGHT side
