CORE ACCEPTANCE CRITERIA 旧件验收标准

Cylinder Heads

Cylinder Heads / 缸盖

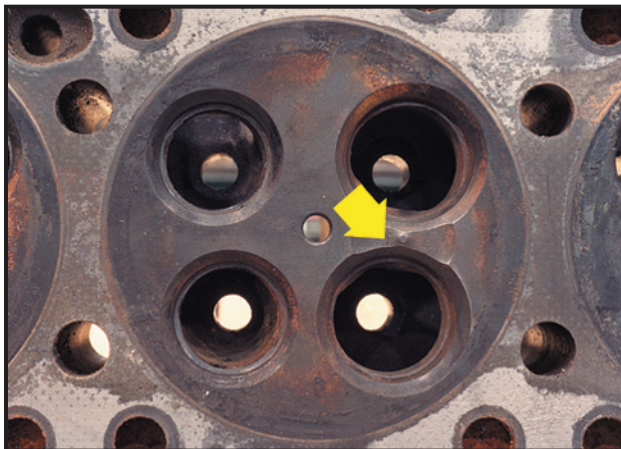
Figure 1
图 1

Full Core Refund
全部旧件退款

Cracks in the combustion face flycut area between the intake valves do not affect core refund
进气门之间的燃烧面高速切削区域中的裂纹不影响旧件退款

A head with cracks in the combustion face flycut area (machined depression between intake valves) is acceptable for Full Core Refund (see Figure 1) if it meets all other Full Core Refund criteria.

如果符合所有其它“全部旧件退款”标准，在燃烧面高速切削区域有裂纹的缸盖（进气门之间的机加工凹陷处）可接受为“全部旧件退款”（见图 1）。

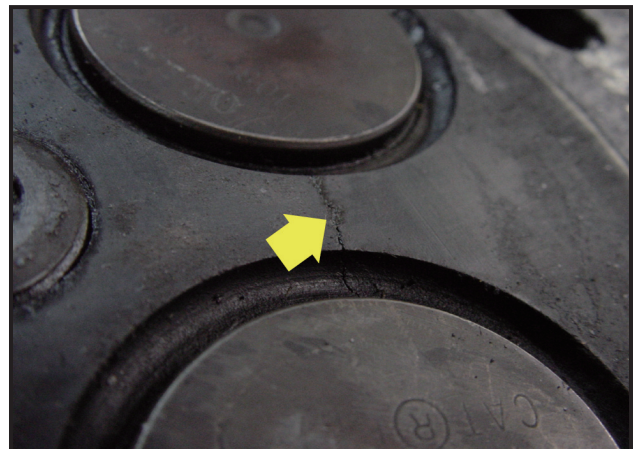
Figure 2
图 2

Damaged Core Refund
受损旧件退款

Crack on the bottom deck
底部平台上的裂纹

Cracked cylinder heads are acceptable for Damaged Core Refund. Cracks are often difficult to locate. For best results, scrape away excess oil, dirt, and carbon. Shine a flashlight at an angle rather than straight at the head. Cylinder heads typically crack in the fire ring area on the bottom deck (See Figure 2) or on the top deck (See Figure 3). One good indicator that a top deck crack may be present is a buildup of sludge (dirt and oil) near the crack (See Figure 4). You can usually find these cracks by carefully inspecting the top decks between adapter holes and freeze (core) plugs. The following are areas to check carefully:

图 2）或顶部平台（见图 3）上的燃烧环区域出现裂纹。顶部平台上可能出现裂纹的一个很明显的标志是在靠近裂纹的地方有油泥（尘土和机油）堆积（见图 4）。你通常可以通过仔细检查接头孔和防冻（中心）塞之间的顶部平台来发现这些裂纹。以下是要仔细检查的区域：

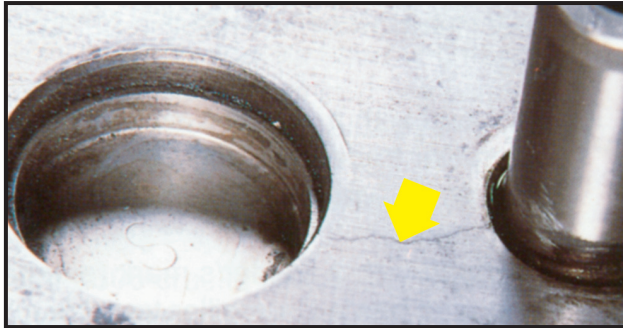
Figure 3
图 3

Damaged Core Refund
受损旧件退款

Crack on the top deck
顶部平台上的裂纹

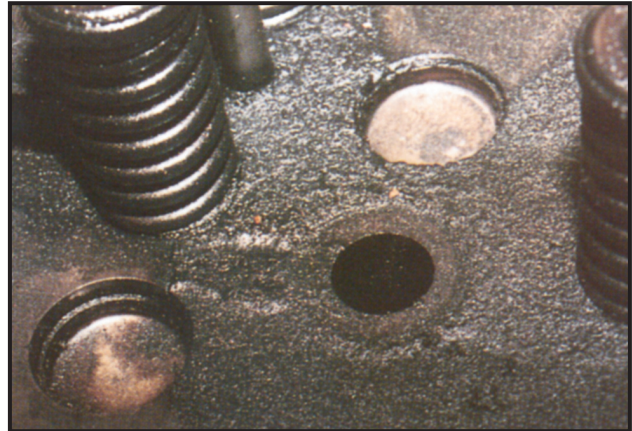
Figure 4
图 4

Damaged Core Refund
受损旧件退款

Top deck crack
顶部平台裂纹

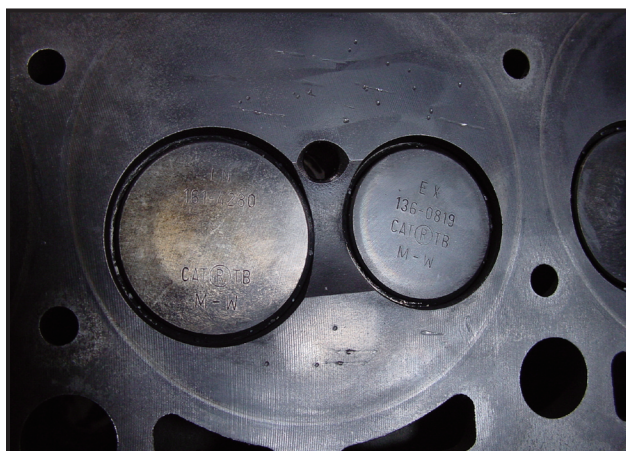
Figure 5
图 5

Full Core Refund
全部旧件退款

Small dents
小凹痕

Minor damage such as small dents, light scratches, and minor gouges to the bottom deck of the head that can be removed by milling are acceptable for Full Core Refund. Care must be used in handling and shipping; heads damaged in transit can be downgraded. Exterior marks, scratches, and gouges to the head (non top or bottom deck) not affecting operation are acceptable (See Figures 5, 6, 7, and 8).

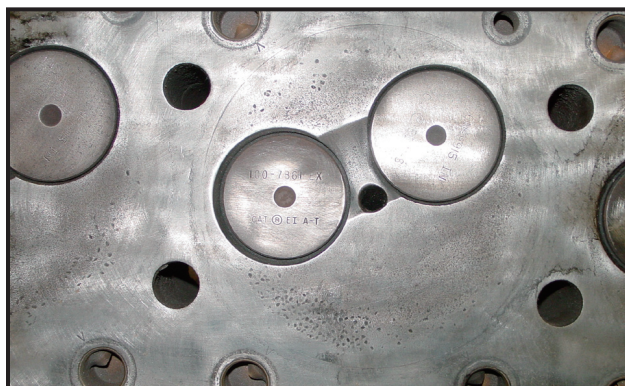
Figure 6
图 6

Full Core Refund
全部旧件退款

Minor damage — multiple small dents
轻微损坏 — 多个小凹痕

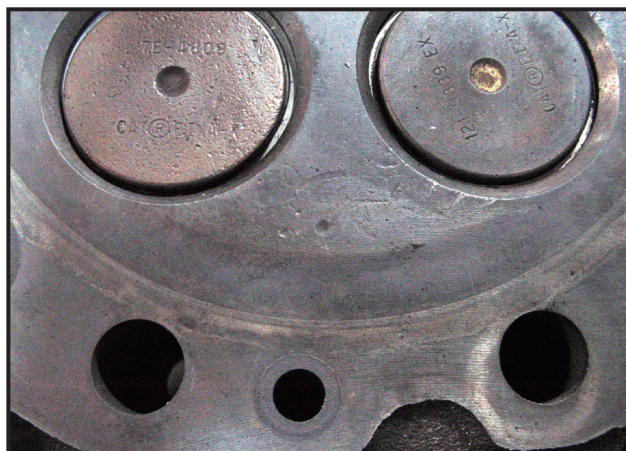
Figure 7
图 7

Full Core Refund
全部旧件退款

Minor damage — single dent
轻微损坏 — 单个凹痕

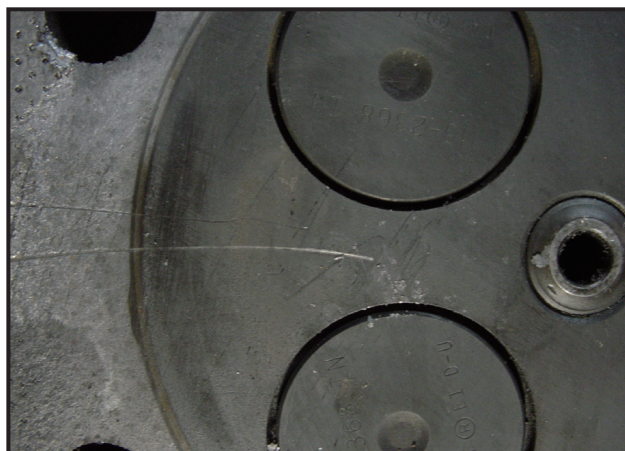
Figure 8
图 8

Full Core Refund
全部旧件退款

Minor damage — single light scratch
轻微损坏 — 单个轻微划痕

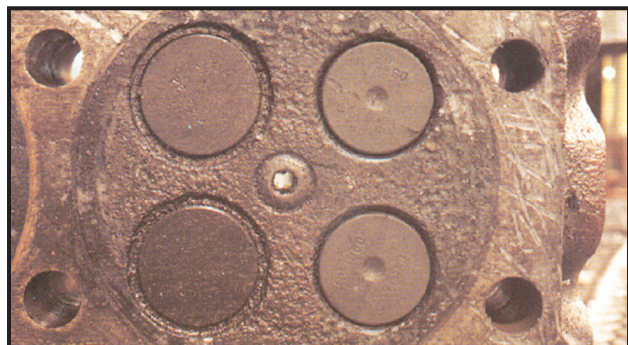
Figure 9
图 9

Pitting
穴蚀

Full Core Refund
全部旧件退款

Pitting which occurs through normal operation will be acceptable for Full Core Refund. Pitting is defined as the flaking of metal caused by the presence of moisture during operation. Pitting usually occurs in the fire ring area of the bottom deck or around exhaust ports (See Figure 9).

在正常运转过程中产生的穴蚀可接受为“全部旧件退款”。穴蚀的定义为在运转中因潮湿而造成的金属材料剥落。穴蚀通常出现在底部平台上的燃烧环区域或排气口周围（见图 9）。

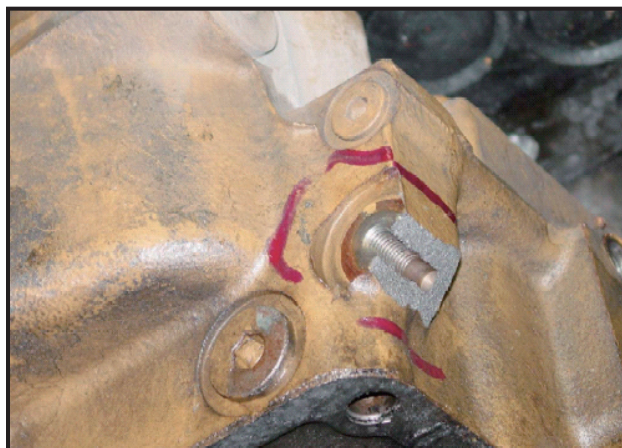
Figure 10
图 10

Minor cosmetic damage to or around bolt holes
螺栓孔或孔周围微小的表面损伤

Full Core Refund
全部旧件退款

Stripped threads, minor cosmetic damage around bolt holes, broken bolts, and broken studs are acceptable (See Figure 10). Please do not break studs for packaging purposes if they cannot be removed.

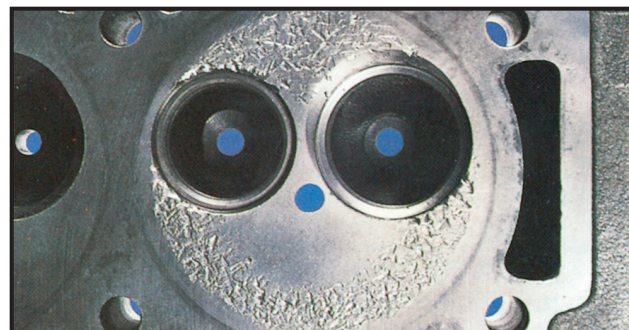
Figure 11
图 11

Severe damage
严重损坏

Damaged Core Refund
受损旧件退款

A severely damaged cylinder head is acceptable for Damaged Core Refund. Severe damage is usually caused by debris from a major engine failure such as dropped valves, damaged pistons, or injector tips (See Figures 11 to 14). No add charge will be made for valves damaged due to a component failure within a cylinder. Metal stamps and/or punch marks on the bottom deck will receive a Damaged Core Refund (See Figure 15).

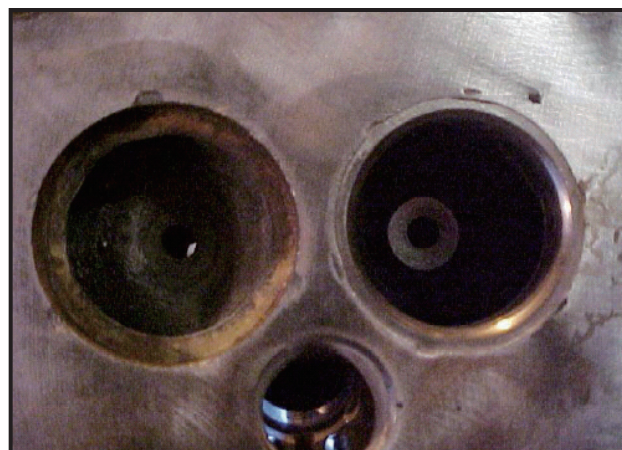
Figure 12
图 12

Multiple punch marks around valve seats
气门座周围的多个冲压痕迹

Damaged Core Refund
受损旧件退款

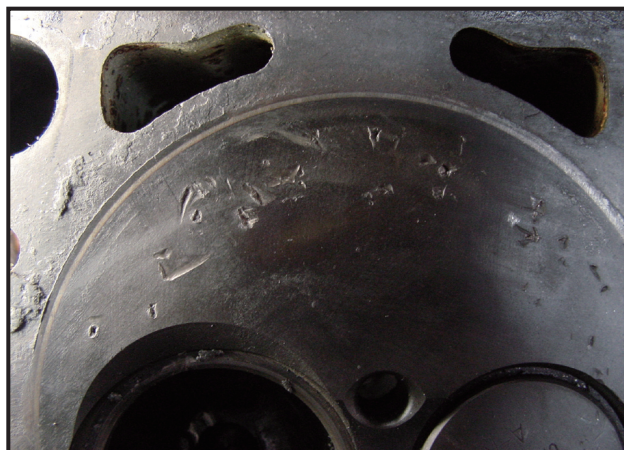
Figure 13
图 13

Damaged Core Refund
受损旧件退款

Deep gouge in head
缸盖上深的擦伤

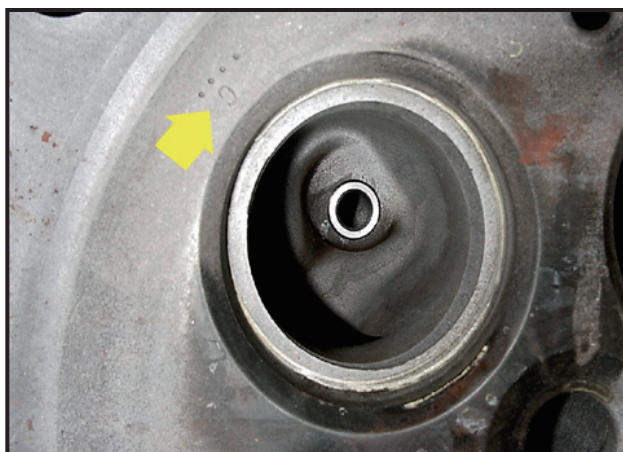
Figure 14
图 14

Damaged Core Refund
受损旧件退款

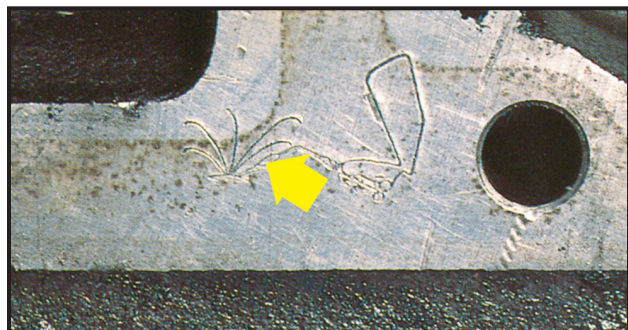
Figure 16
图 16

Damaged Core Refund
受损旧件退款

Welder's mark
焊接方标记

- A head with a welder's mark (even if the head also has a Caterpillar trademark) (See Figure 16).
- 带有焊接方标记的缸盖（即使缸盖还有一个卡特彼勒商标）（见图 16）。
- A head with a visible weld and no Caterpillar trademark. Figures 17, 18 (A), 19, and 20 show some typical non-Cat welds.
- 带有可看见的焊缝但没有卡特彼勒商标的缸盖图 17、18 (A)、19 和 20 中所示为几个典型的非卡特彼勒焊接。
- Welding in the fire ring area is never cosmetic and will result in Damaged Core Refund if welded by a source other than Caterpillar.
- 在燃烧环区域的焊接绝不是表面焊接，而且如果由非卡特彼勒的其它方进行焊接，其结果是“受损旧件退款”。

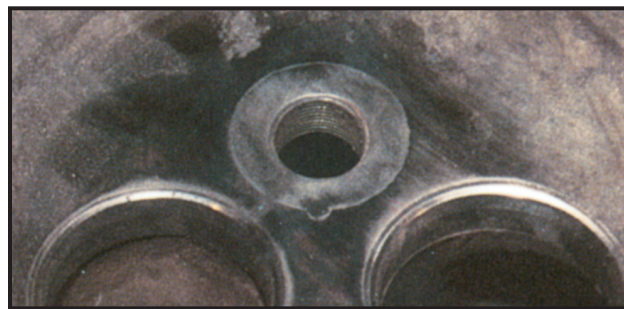
Figure 17
图 17

Damaged Core Refund
受损旧件退款

A plug that is not cast-iron has been welded into this head to replace a cracked area around the adapter hole.

一个不是铸铁的塞子被焊入此缸盖中，来代替接头孔周围的有裂纹区域。卡特彼勒不使用这种方法。

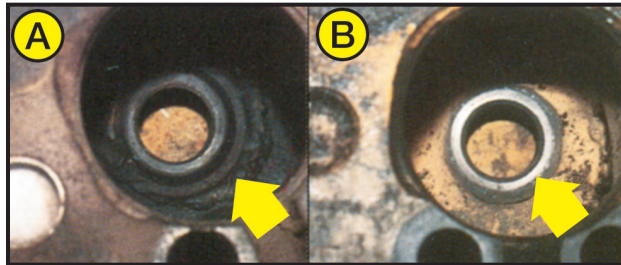
Figure 18
图 18

Damaged Core Refund
受损旧件退款

Photo A - This view from the top of the head with the nozzle adapter (pre-chamber) removed shows a rough, jagged weld where a bottom deck crack has been repaired.

照片 A — 这一视角是从已拆下喷嘴接头（预燃室）的缸盖顶部看，所示是在修补底部平台裂纹的地方有一条粗糙而且参差不齐的焊缝。

Photo B - The view shows the same area in an un-welded Cat casting. The Cat casting is smooth. Normally, nozzle adapters (pre-chambers) are not removed during core inspection, but if the adapters fall out during inspection, the adapter hole area will be checked.

照片 B — 这一视角所示是在一个未焊接的卡特彼勒铸件。卡特彼勒铸件很平滑。通常，在检查旧件过程中不拆下喷嘴接头（预燃室），但如果接头在检查过程中掉落，将检查接头孔区域。

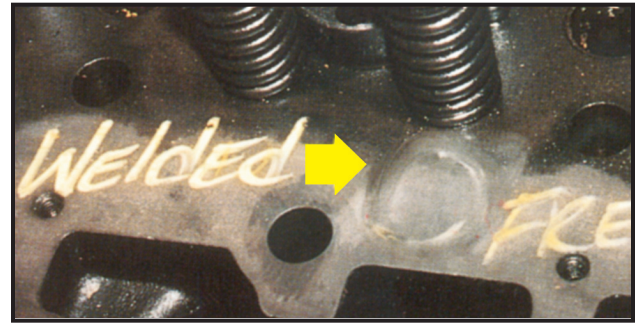
Figure 19
图 19

Damaged Core Refund
受损旧件退款

This head probably had a top deck crack and was repaired by welding the freeze (core) plug hole shut. Caterpillar does not weld top deck cracks nor does Caterpillar weld over a freeze (core) plug hole.

此缸盖可能有一条顶部平台裂纹，并通过将防冻（中心）塞孔焊接封闭而进行了修补。卡特彼勒不会焊接顶部平台裂纹，卡特彼勒也不会焊接防冻（中心）塞孔。

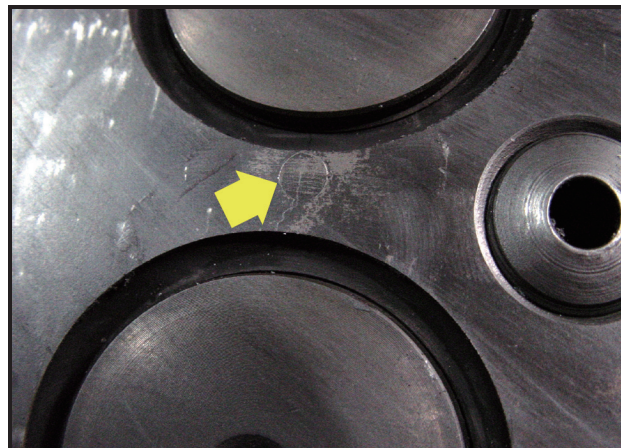
Figure 20
图 20

Damaged Core Refund
受损旧件退款

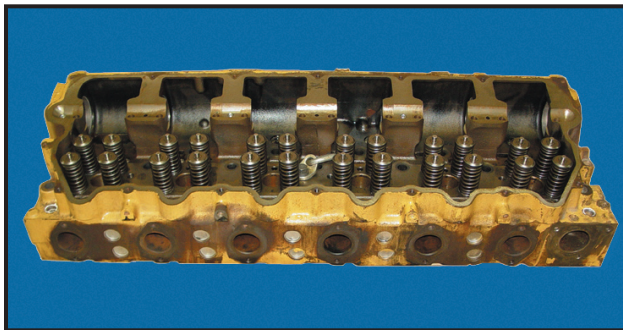
Figure 21
图 21

Complete cylinder head group
完整的缸盖组件

下列零件应包括在缸盖组件中：

- Head casting
- 缸盖铸件
- Valves
- 气门
- Springs
- 弹簧
- Guides
- 导管
- Adapters (when applicable)
- 接头（如果适用）

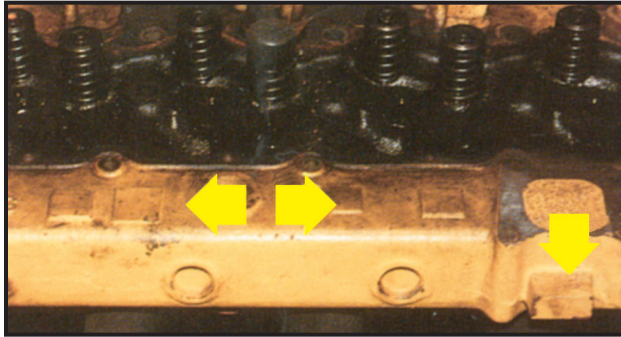
Figure 22
图 22

Competitors' head
竞争对手缸盖

If you find this symbol or other manufacturers' markings, the core is only acceptable in exchange for an Upgrade-to-New head casting. Cracked, uncracked or welded heads originally manufactured by sources other than Caterpillar will be accepted for Damaged Core Refund only in exchange for an Upgrade-to-New head casting. Other indicators of not being a Caterpillar head can be found in the casting itself. Figure 23 shows the parting line and “buttons” on a Cat casting. Compare this to the square “pads” on the heads that are not Caterpillar, Figure 22. Some of these pads appear to be the same size as the markings used by Ghinassi, even though the Ghinassi symbol is not evident. The large, raised block of iron at the right of the “pads” along the parting line is also a clear alert that the head is not a Caterpillar head.

如果你发现此符号或其它制造商的标记，旧件仅能接受为交换升级到新部件的缸盖铸件。原来由非卡特彼勒的其它方制造的有裂纹、无裂纹或焊接缸盖仅接受为“受损旧件退款”，用于交换升级到新部件的缸盖铸件。可以在铸件本身上发现一些说明这不是卡特彼勒缸盖的其它标志。图 23 中所示为卡特彼勒铸件上的分型线和“按钮”。将此图与图 22 中非卡特彼勒的缸盖上的方形“凸台”相比较。即使 Ghinassi 符号并不明显，这些凸台中有一些看起来与 Ghinassi 采用的标记相同。沿着分型线的右侧“凸台”上的大突起铁块也清楚地表明了此缸盖不是卡特彼勒缸盖。

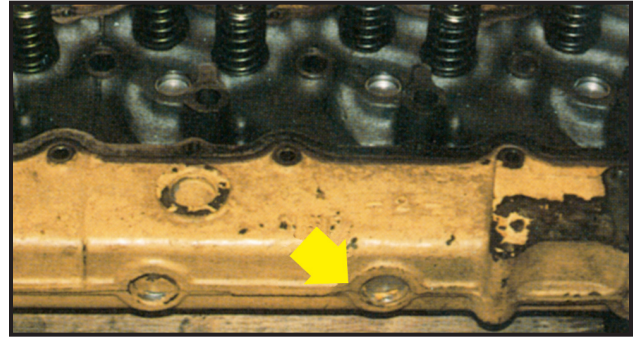
Figure 23
图 23

Caterpillar head — parting line
卡特彼勒缸盖 — 分型线

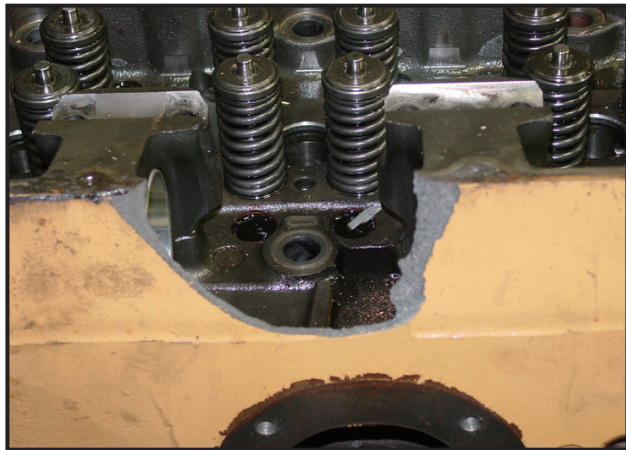
Figure 24
图 24

No Core Refund
无旧件退款

Broken casting
破损的铸件

Cylinder heads with a piece of the casting missing which affects the integrity or operation of the head will result in No Core Refund.
