# Main Oil Line (MOL) Booster Pump Repairs to Enhance Safety and Productivity

Repair protocol delivers innovative solution aligned with field change requests and safety mandates

## Case Study

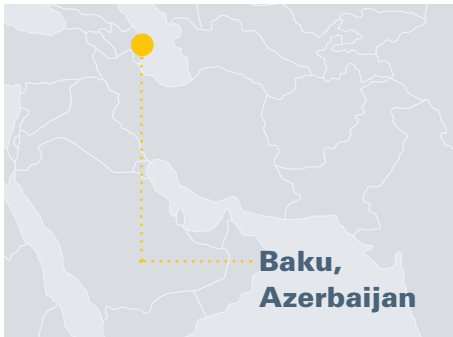
SPM Oil & Gas' Center of Manufacturing and Engineering Excellence in Baku enables oil and gas companies to reduce total cost of ownership (TCO) and nonproductive time (NPT) by providing superior engineering expertise to identify and repair damaged equipment quickly with quality materials, backed by a warranty.

SPM Oil & Gas technicians restored the MOL Booster pump by replacing all damaged parts including mechanical seals, thrust bearings, impeller and casing rings, lower bearing, gaskets, and O-rings. Technicians also machined the flange surfaces to  $\frac{3}{4}$ " and balanced the rotors.
