# VISIBLE Defects HEAT EXCHANGER INSPECTION SYSTEM

A unique method of visually evaluating the integrity of a gas furnace heat exchanger. The Visible Defects System consists of a specially designed delivery of a penetrant for identifying the tiniest hairline cracks in the heat exchanger.

# **INSTRUCTION BOOKLET**

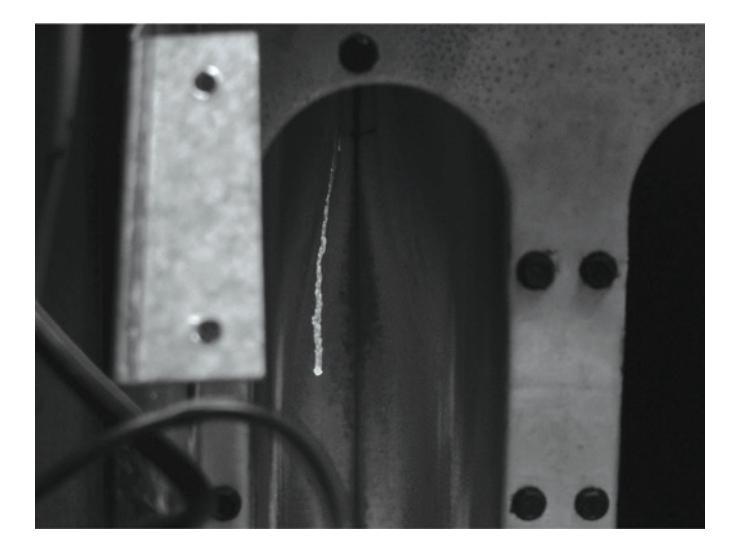
This picture shows Visible Defects Crack Finder illuminated by a black light flashlight. The penetrant makes the defect easy to find and verifies there is a breach from the air side to the combustion side of the heat exchanger.

Inspection is performed with the supplied LED UV flashlight to see if any of the solution has penetrated to the opposite side of the heat exchanger (air side or combustion side depending on its design).
