# 6060 HD Tracks

Bushings for Life

**Machine:** Cat® 6060 Hydraulic Mining Shovel

Cat 512-0710/512-0711 Heavy Duty (HD) Track

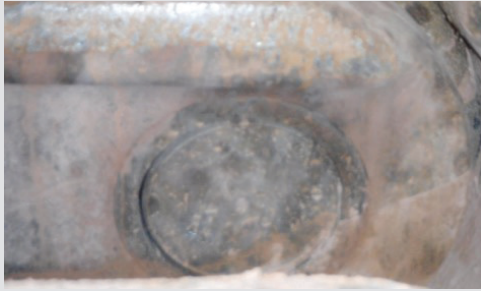
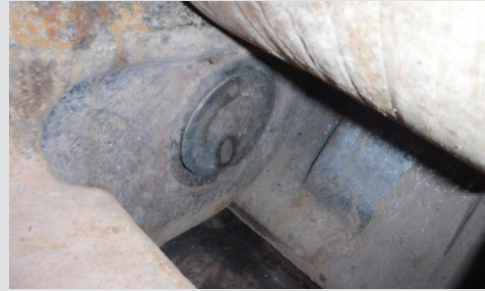
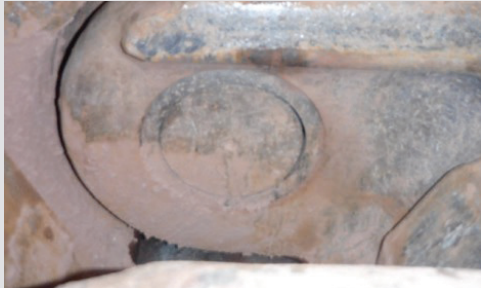
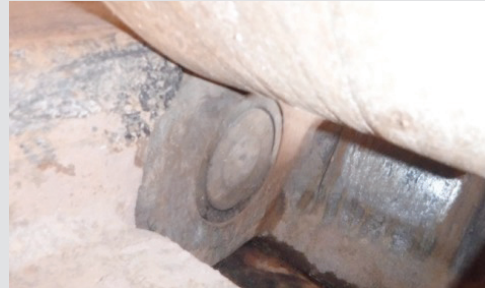
**“Only 10%-  
20% pitch  
extension  
in 13,000  
hours.”**

The customer tried the new 6060 HD tracks with high interference, straight bushings. During May 2019, the customer performed inspection of the tracks at 13,000 hours. The bushing had remained in place without any movement. The pitch extension measured between 10% and 20%, so the track is projected to last past the 20,000-hour track life.

A gold mine in Mexico was looking for improvements to their 6060 track joints. Using the Legacy HMS track design, the flange on the bushing cracked, which required additional maintenance on the tracks.
