## Extending the life of Coal Nozzle Burner Tips For Raichur Thermal Power Station

### The Kennametal Conforma Clad Solution - Field Test

## The Results

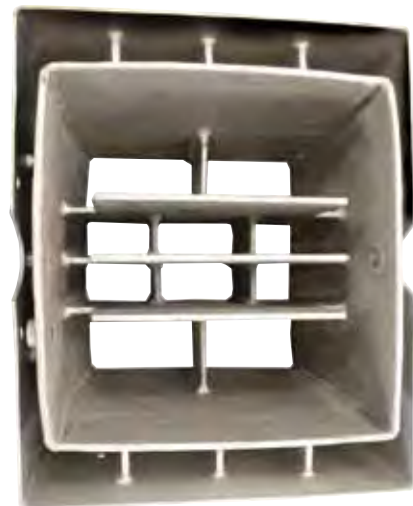
In November 2006 Kennametal Conforma Clad began a field test with two burner tips placed side-by-side in one of RTPS's units. One of the tips was the standard SS 310 weld overlay protected piece while the other was SS 310 protected with 1.0 mm of Kennametal Conforma Clad™ infiltration-brazed tungsten carbide which metallurgically bonds with the base substrate (SS 310). After one year of service, both coal nozzle tips were removed and examined.

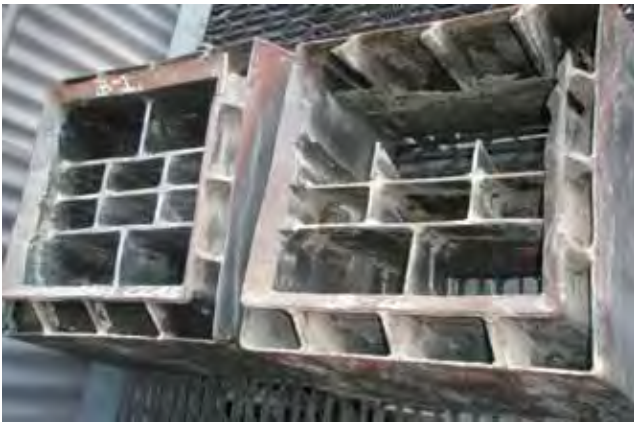
*Side by side comparison (boiler side view) of the weld overlay protected coal nozzle tip (right) and the Kennametal Conforma Clad tip (left).*

The weld overlay protected tip showed extreme erosion - the top splitter was completely eroded and severe erosion was found in the rest of the splitters and partition plates (right top photo). The inner annulus plate was severely eroded on the boiler side of the weld overlay protected tip (bottom left photo). The Kennametal Conforma Clad protected tip maintained its size and shape and showed no erosion on the boiler side (bottom right photo). Using these results, the Kennametal Conforma Clad burner tip was expected to last a minimum of two years. However, after reviewing the findings of the field test, Kennametal Conforma Clad designed an improved coal nozzle tip for RTPS with improved protection on the splitter, leading edge and top plate that extended the performance of the tips even further.

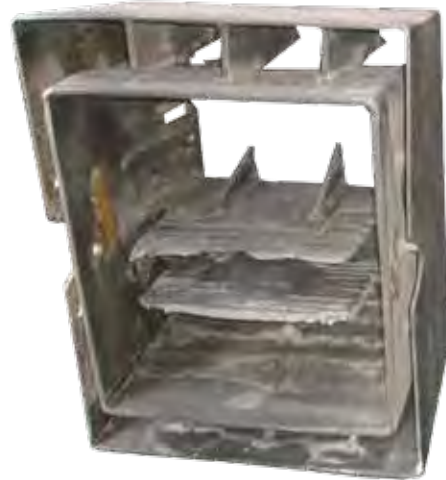
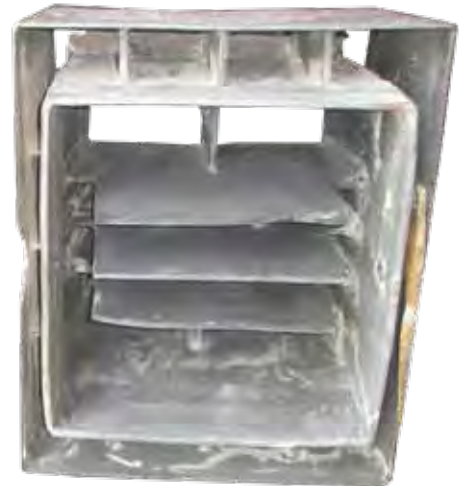
*Comparison of weld overlay protected coal nozzle tip (top) and the Kennametal Conforma Clad tip (bottom) from coal entry side.*
